J Fail. Anal. and Preven. (2017)
17:642-646
DOI 10.1007/s11668-017-0293-4

A Case Study on Using Corrosion Analysis in Forensic Engineering

Reza Mirshams

Case Review: Galvanic Corrosion in a Water Supply Plumbing System

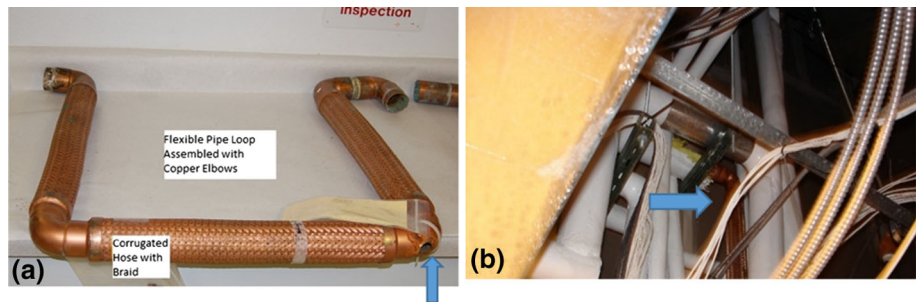
Fig. 1 (a) Flexible corrugated hose pipe connector and location of a drainage port on copper elbow. (b) Location of a flexible pipe in the plumbing structure of building

A large water leak caused major damage in a high-rise building. The water leak was due to failure of assembled drain couplings on copper elbows in flexible braided hose connectors. Figure 1 shows one of the flexible corrugated hose pipes and its location in the building.

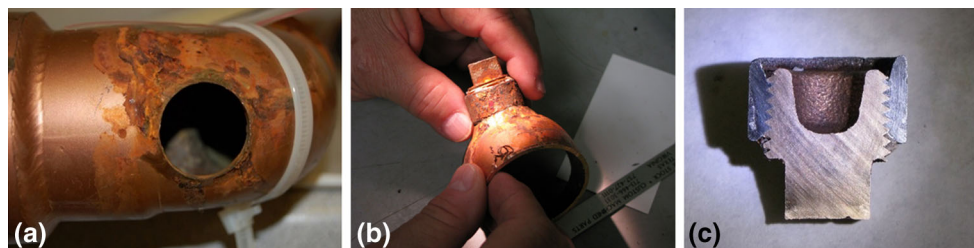
Fig. 2 Failed copper joint (a), the brazed steel coupling with plug (b), and cross section of coupling with plug

There was no fracture of the braze metal or of the steel coupling. It was clear that corrosive attack penetrated along the interface between the braze metal and the outer surface of the steel coupling. That galvanic corrosion produced a

scale in the interface that separated the joint, and resulted in the detachment of the drain port from the elbow under system pressure.

Exposure of relatively large area of copper with respect to iron resulted in accelerated galvanic corrosion of the iron and the destruction of the braze joint holding the steel coupling in the copper elbow. There was no corrosion of the copper. Only the steel coupling was corroded. It is concluded that installation of a steel coupling for drain port on the copper elbow was an improper decision.

of a drain port with a steel coupling on a copper elbow was an improper decision. To prevent galvanic corrosion, interaction of dissimilar metals should be avoided in a wet environment.

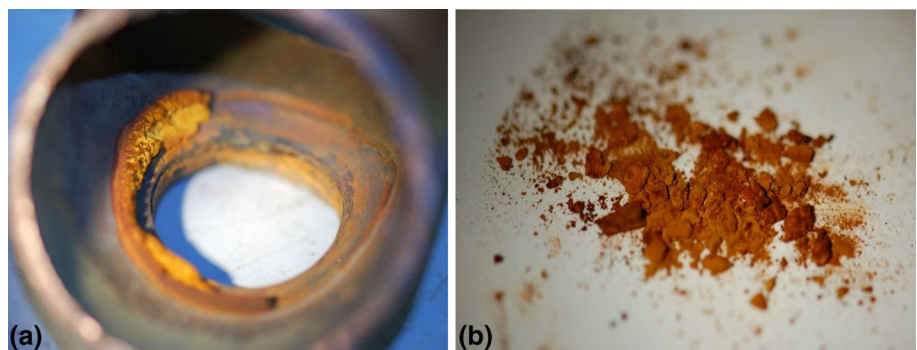
Fig. 3 Inside of the corroded copper elbow (a) and corrosion powder product (b)

After photographic documentation, a square section was removed from the copper elbow. When the inside surface of the elbow was exposed to view, a bright orange deposit was observed nearly around the hole from which the drain port had separated. Energy-dispersive spectroscopy (EDS) analysis revealed that this material was ferric hydroxide [$\text{Fe}(\text{OH})_3$ —rust]. Microscopic examination of the inside diameter of the fracture surface of the weld metal attached to the elbow revealed a layer of reddish scale. That scale was also identified with the EDS to be rust. Figures 2, 3, 4, and 5 show the failed copper elbow, coupling and plug, surface dust, scanning electron microscopy of the failed surface, metallographic microstructure, and EDS analysis.

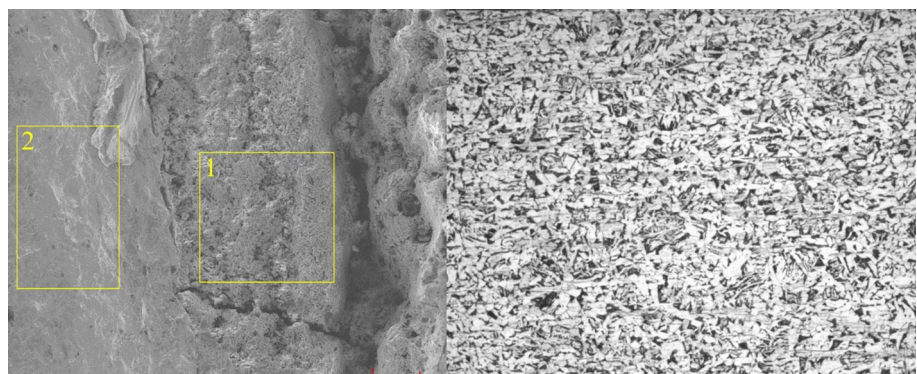
Fig. 4 Representative pictures of SEM (left) and metallography (right) of copper pipe and steel plug

A metallographic section through the elbow and the weld deposit was prepared and polished. EDS analysis of the elbow portion revealed essentially pure copper. EDS analysis of the braze deposit portion revealed copper with about 4.4 percent silicon and about 1.6 percent manganese. Average microhardness of the copper elbow was determined to be 69 HK200, and average microhardness of the weld deposit was determined to be 126 HK200.

Macroscopic examination, microscopic examination, and SEM microscopic examination revealed that the

bottom end of the drain port was a preferred site for pitting in a manner consistent with galvanic corrosion. The metallographic section also revealed deep corrosive attack.

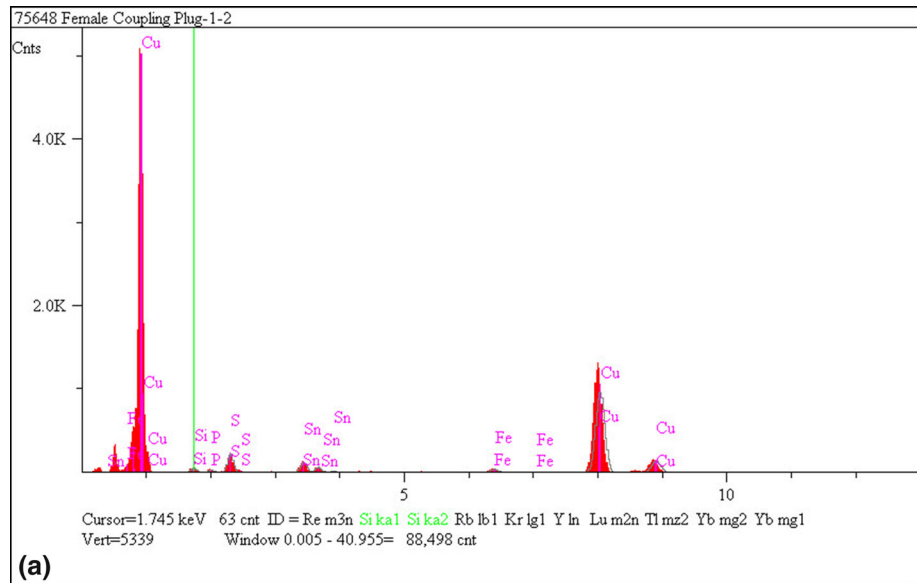
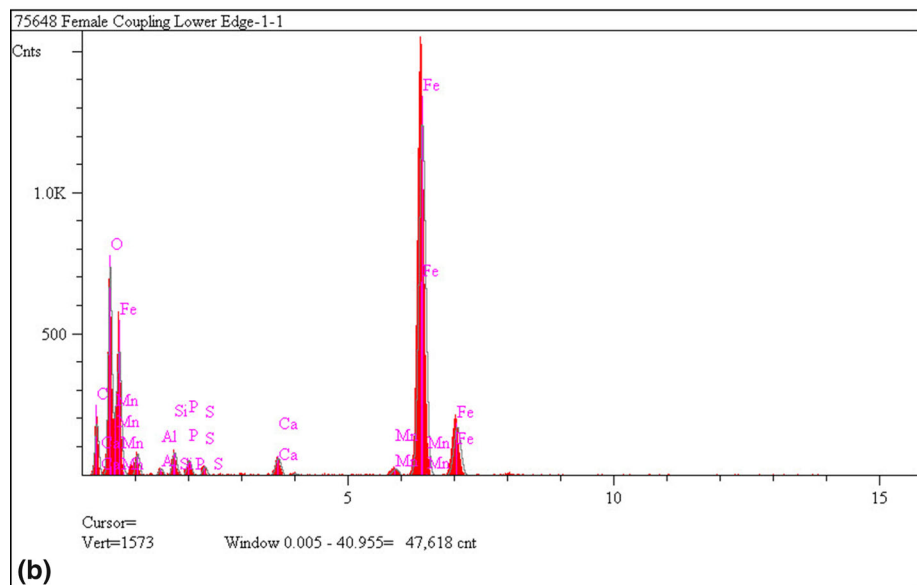
EDS analysis of the gray surface on the steel drain port revealed steel with no copper present. This surface had been part of the welded joint. EDS analysis of the copper-colored area above the gray area revealed a copper-filled organic coating. Quantitative chemical analysis in the optical emission spectrometer of the coupling revealed a carbon steel that does meet the compositions for carbon steel forgings for piping applications per ASTM A105 [7]. Table 1 presents chemical compositions of the drain port coupling. The steel contained high sulfur and manganese contents, like to free machining steel Table 1. The etched metallographic section through the steel connector revealed the manganese sulfide stringers typical of free machining steel. Chemical analysis of the plug identified a copper alloy with approximately 80% copper and 10% tin, Fig. 5.

Fig. 5 Energy-dispersive spectroscopy (EDS) of (a) the plug, (b) the coupling
