# Stress Corrosion Cracking (SCC)<sup>1</sup>

Reza Mirshams, Ph.D., P.E.  
Materials Engineering Services, LLC  
Reza @MyMetalExpert.com

## **Case Study: Chloride Stress Cracking of Austenitic Stainless Steel Tubes**

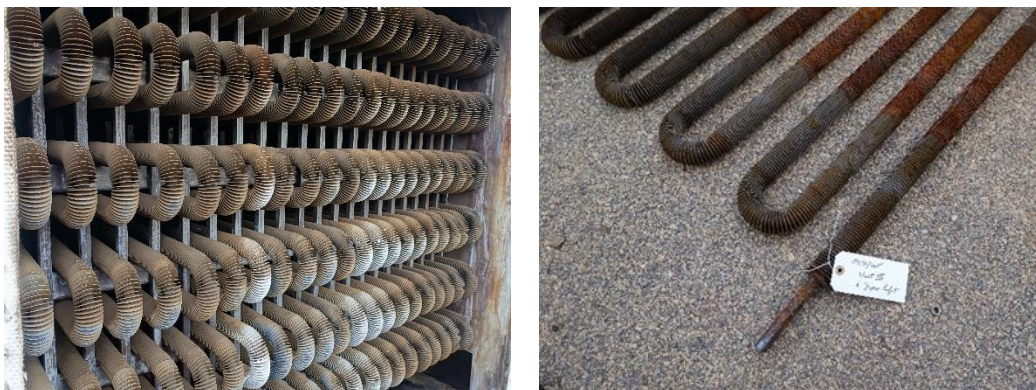
Heat exchanger units were designed for increasing temperature of feed water to boiler units from 125° to 175° C. To increase temperature of boilers feed water, it was planned to recover heat from reciprocating exhaust of diesel engines with a temperature range of 300° to 650° C. Diesel engines operated by natural gas. Each coiled tube was fastened to the structure of heat exchanger unit, Figure 1.

Figure 1: The heat exchanger unit and assembled tubes.

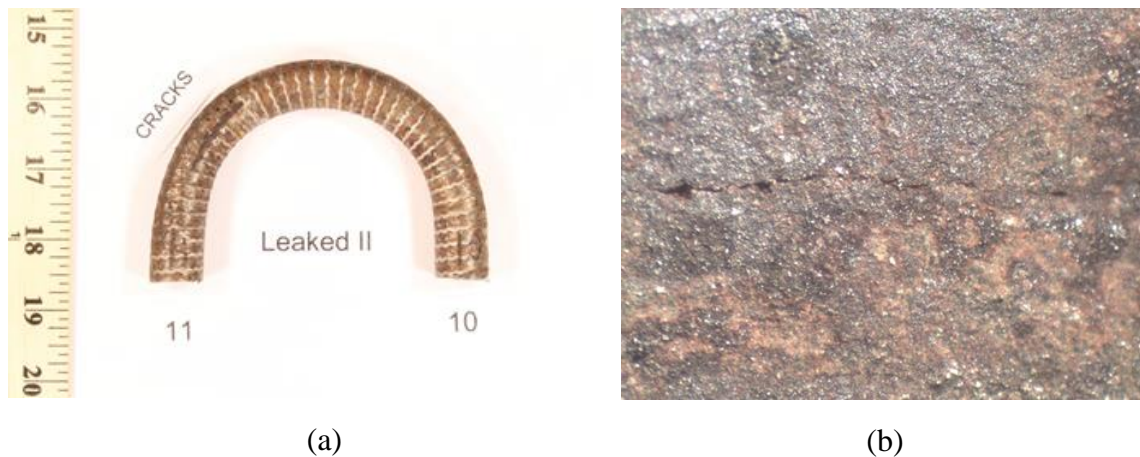
As received heat exchanger tube coils were photographed prior to removing them from their shipping box. It was observed that the bottommost straight runs of each coil were deformed and sagging downwards. White deposits were observed on the exterior surfaces of and appeared to have been originating.

The locations of the leaks were known on the U bend areas of the tube. The U bends were also numbered. Eleven U bends were cut from the coil and stripped of their cooling fins. The exterior surfaces were cleaned with tap water and a soft nylon bristle brush to remove the deposits. The U bends were then examined using a stereomicroscope to look for a through wall leak location.

Longitudinal cracking was found U bend samples. The cracking was at the extrados of the bend and occurred at the at the 45-degree position in the 180-degree U bend closest to the no. 11 straight run, Figure 2 (a). The tube was cut transversely at the apex of the bend. When the internal deposits were scraped off, cracks in the inside diameter (ID) surface were not observed. White deposits were found within the tube U bend location. Thin brown deposits were observed and samples were taken for analysis. The tube was observed to possess a longitudinal seam weld.

Figure 2: (a) The bend tube after removal of fins and (b) SCC on the apex of u ben sample/

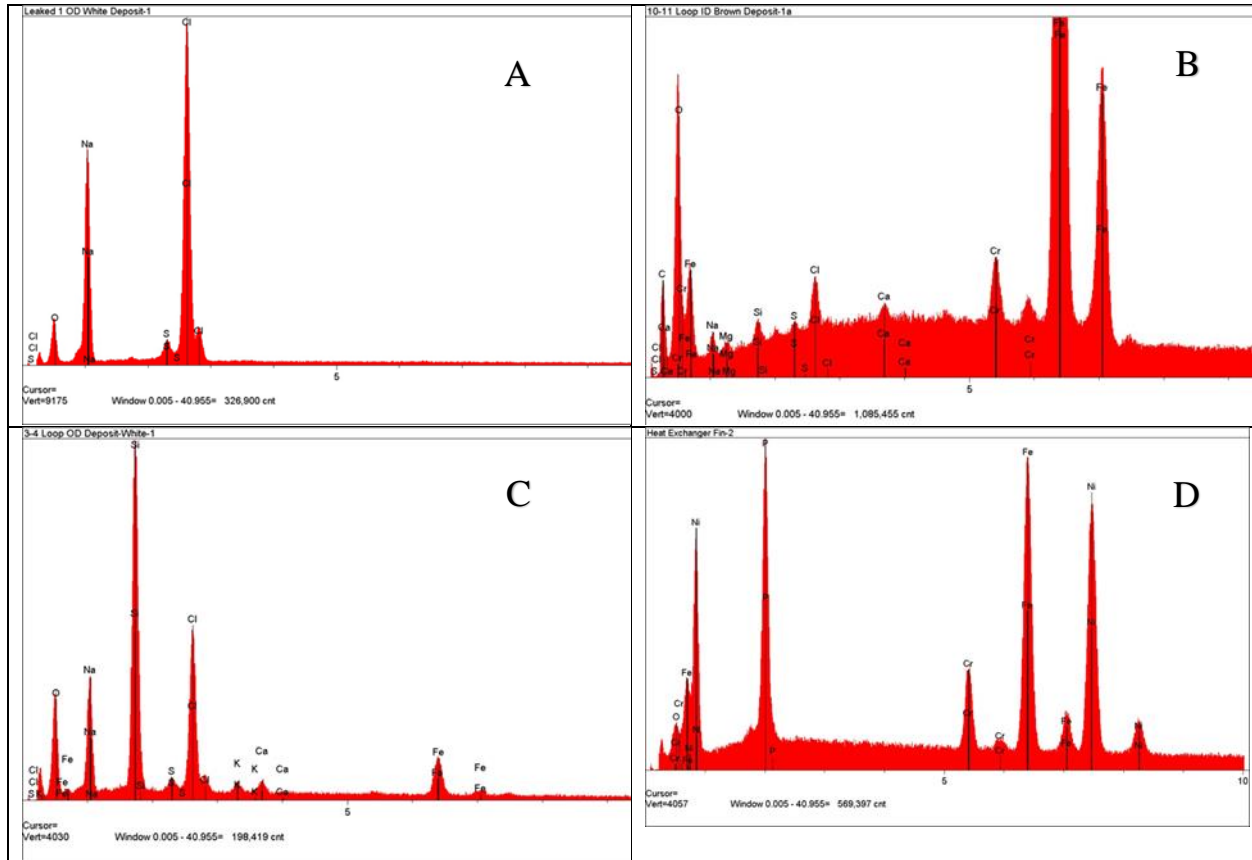
White and brown deposits were analyzed for their elemental compositions using a scanning electron microscope (SEM) equipped with an energy dispersive x-ray spectrometer (EDS). A spectrum of the white deposits on the exterior surface of found sodium and chlorine. A spectrum of the ID brown deposits found some sodium and chlorine, as well. The Outside deposits on tubes were examined and found to contain sodium and chlorine, Figure 3.

Figure 3: (A) EDS Spectra for white deposit powder; (B) Spectra for brown powder deposit; (C) Orange brown powder deposit; (D) Fin edge

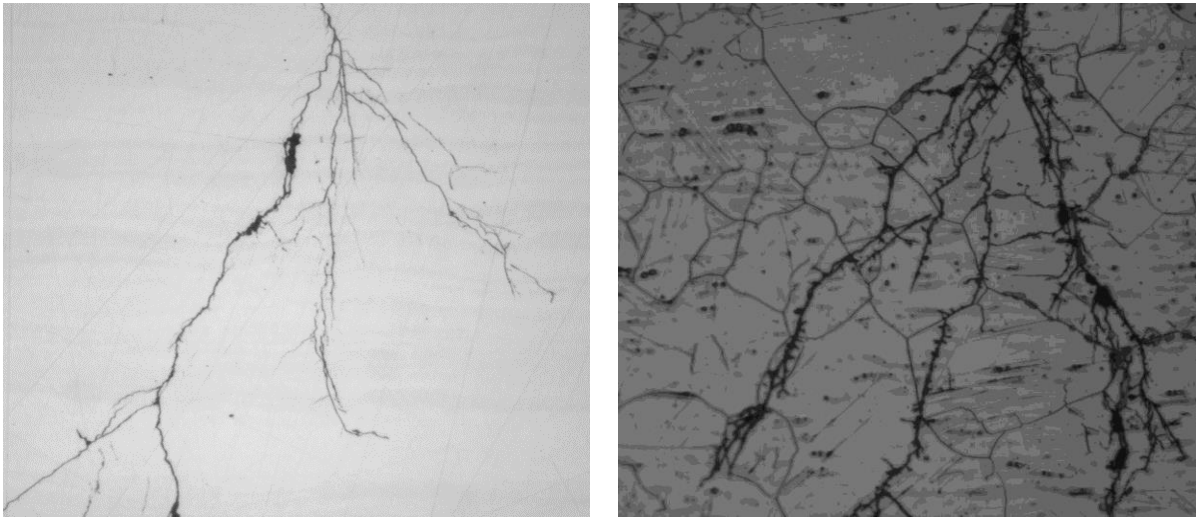
Three transverse cross sections through the longitudinal cracks in the U bend were prepared for subsequent metallographic examination. The cross-sectional area of a tube at the apex of the bend was observed to be smaller than for the tube along a straight run. In the as polished condition several cracks were observed to have initiated at the outside diameter (OD) surface of the tube on the extrados of the bend. All the cracks were observed to exhibit branching which is characteristic of stress corrosion cracking (SCC), Figure 4. Some cracks exhibited more branching than others. For one of the cross sections a few branched cracks were observed on the intrados of the bend 180 degrees away from most of the cracks.

Figure 4: Untetched surface shows SCC crack branching. Crack branching is an indication of stress corrosion showing crack branching cracking. Etchant Nitric acid 60 %, Mag.: 400X.

5. Cross section microscopy indicated the observed cracks exhibit branching which is characteristic of stress corrosion cracking (SCC).
6. There was no indication of chromium carbide precipitation per ASTM A262 Practice A in the samples

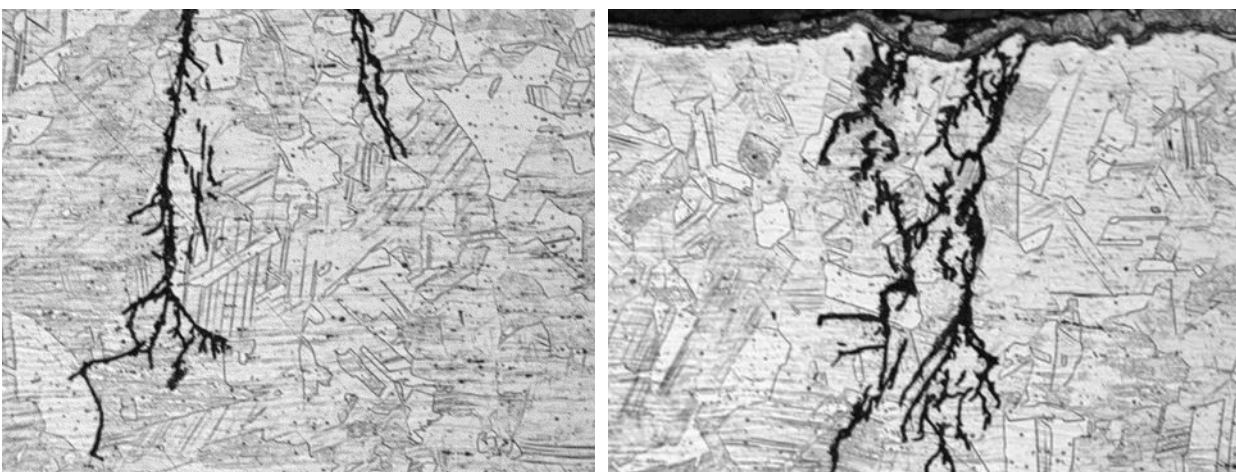
Electrolytic etching with a 10 percent oxalic acid solution as per the requirements of ASTM A262 Practice A also did not reveal the presence of any carbide precipitation. The tube exhibited a step structure, Figure 5. The cracks appear darker and wider after the oxalic acid etch. One of the tube cross sections was etched electrolytically with an aqueous 60 percent nitric acid solution which revealed the grain structure.

Figure 5: Etched metallographic sections after etching per ASTM A262 and appearance of a step structure.

All the cracks were observed to be primarily transgranular although some intergranular crack propagation was also observed. No carbide precipitation was in the cracks.
